Manhole Inspection Summary

Manhole # S27C__011MH

Insp Date: **12/7/07 1:30 PM**

Location Address: **501 FREMONT AVE**

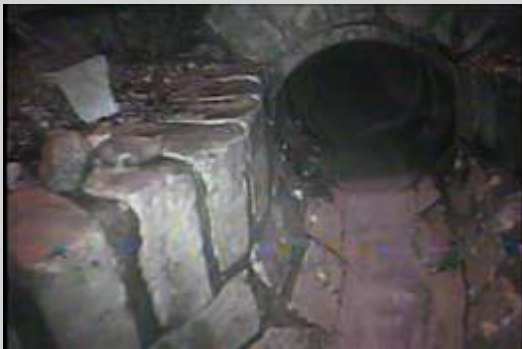
3 O'Clock Inflow

8 in. Circular Gravity Sewer
Pipe In @ 3 O'Clock

Pipe Height: **8.4** (in.) Rod and Bar (Angled)
Pipe Material: **Clay** ☐ Pipe Lined
Invert Depth: **15.03** (ft.) Flow Characteristics: **Slow**
Deposits: ☒ None ☐ Mud ☐ Sludge ☐ Debris ☐ Grease
Silt Depth: (in.) Deposits Extent:
Infiltration: **None** Pipe Seal Cond: **Sound**

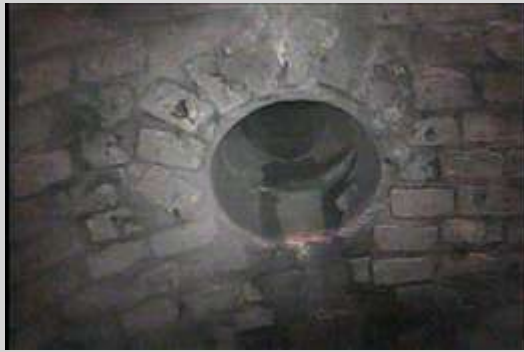
6 O'Clock Inflow

10 in. Circular Gravity Sewer

Pipe In @ 6 O'Clock

Pipe Height: **9.6** (in.) Rod and Bar (Angled)

Invert Depth: **13.18** (ft.) Flow Characteristics: **Fast**

Infiltration: **None** Pipe Seal Cond: **Sound**

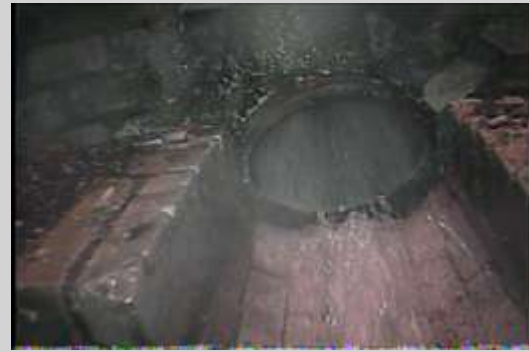
Drop In @ 6 O'Clock

Drop: **Outside** Rod and Bar

Angled: **Yes** Reading: **14.09** (ft.)

Inv Depth: **15.09** (ft.)

Drop Condition: **Open**

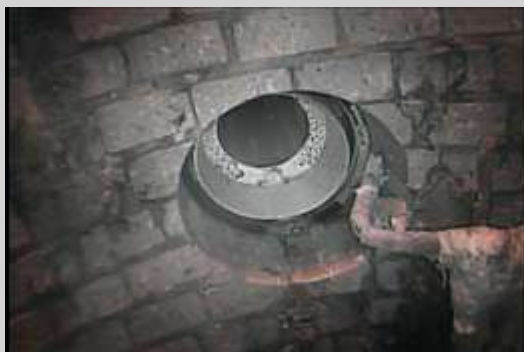
9 O'Clock Inflow

10 in. Circular Gravity Sewer

Pipe In @ 9 O'Clock

Pipe Height: **9.6** (in.) Rod and Bar (Angled)

Pipe Material: **Unknown** ☐ Pipe Lined

Infiltration: **None** Pipe Seal Cond: **Sound**
